Kootenai Development Corporation

Flyway Property

Final Completion of Work Report

December 2004

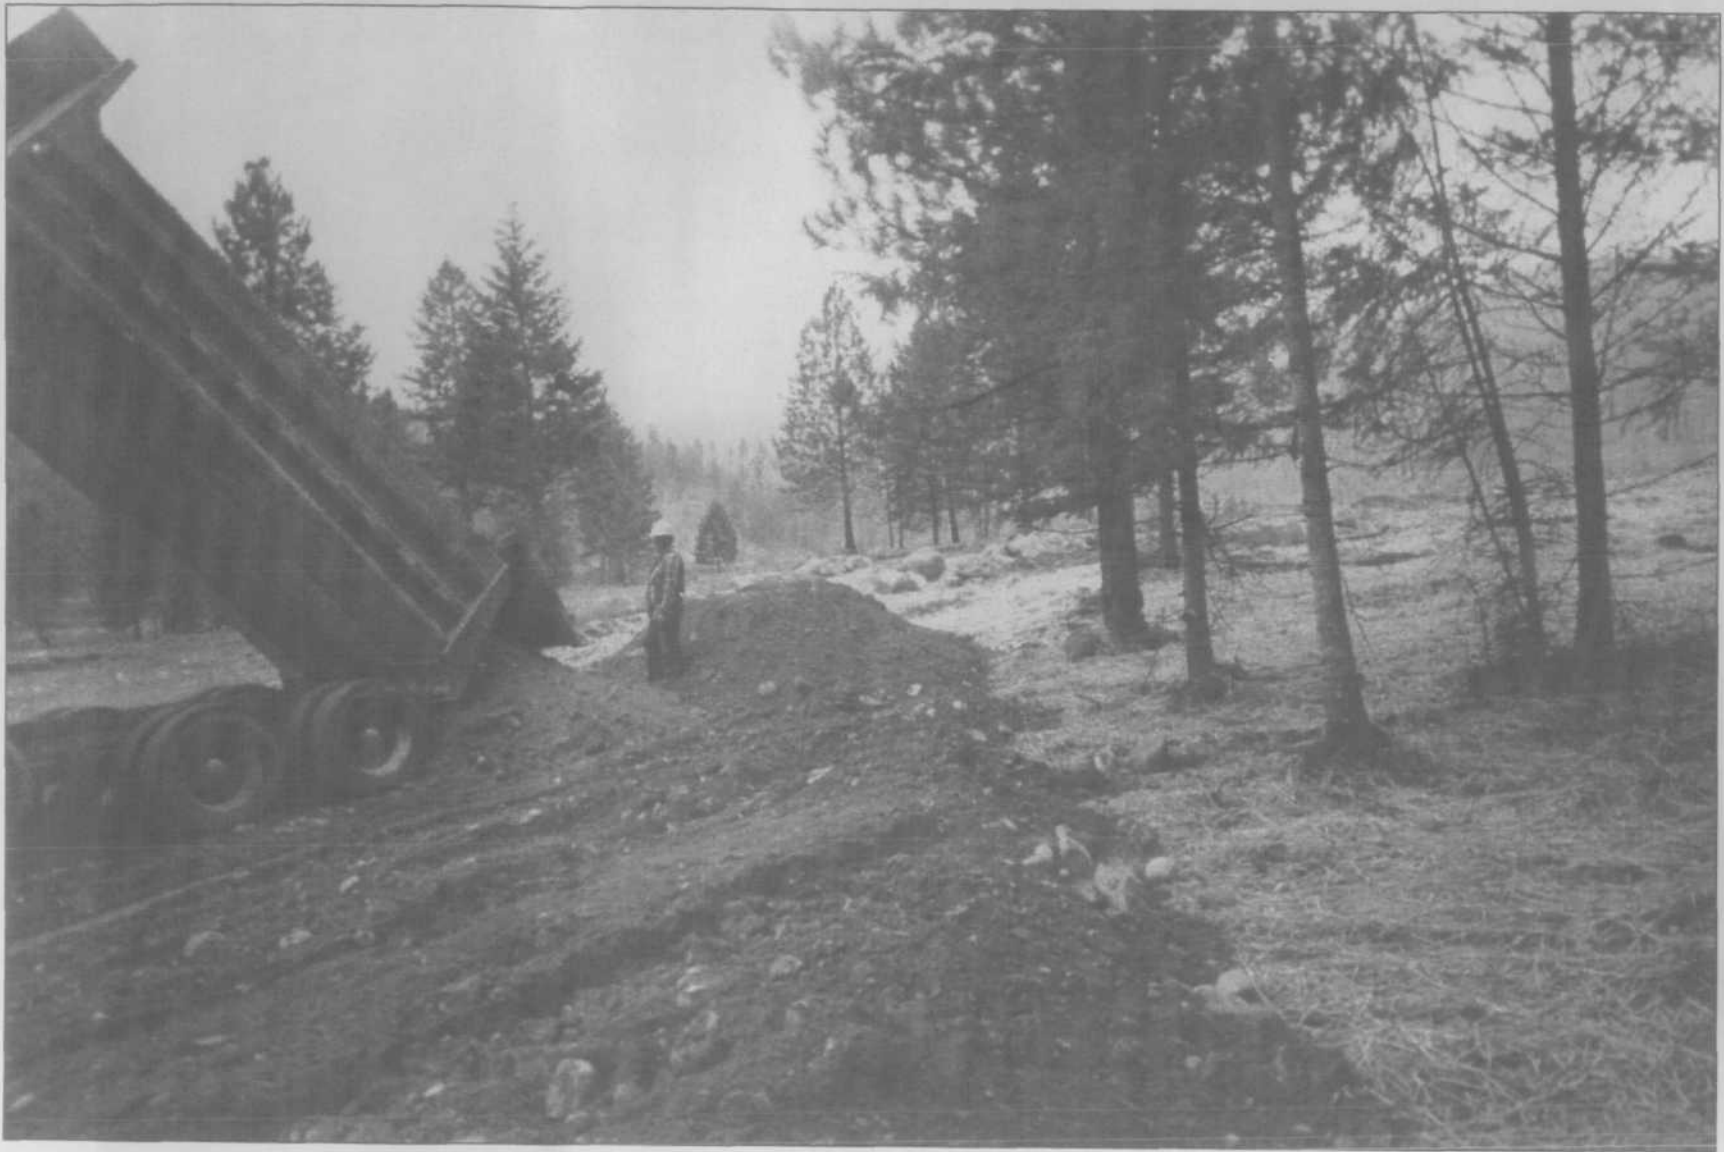
Flyway Site - Dumping Backfill

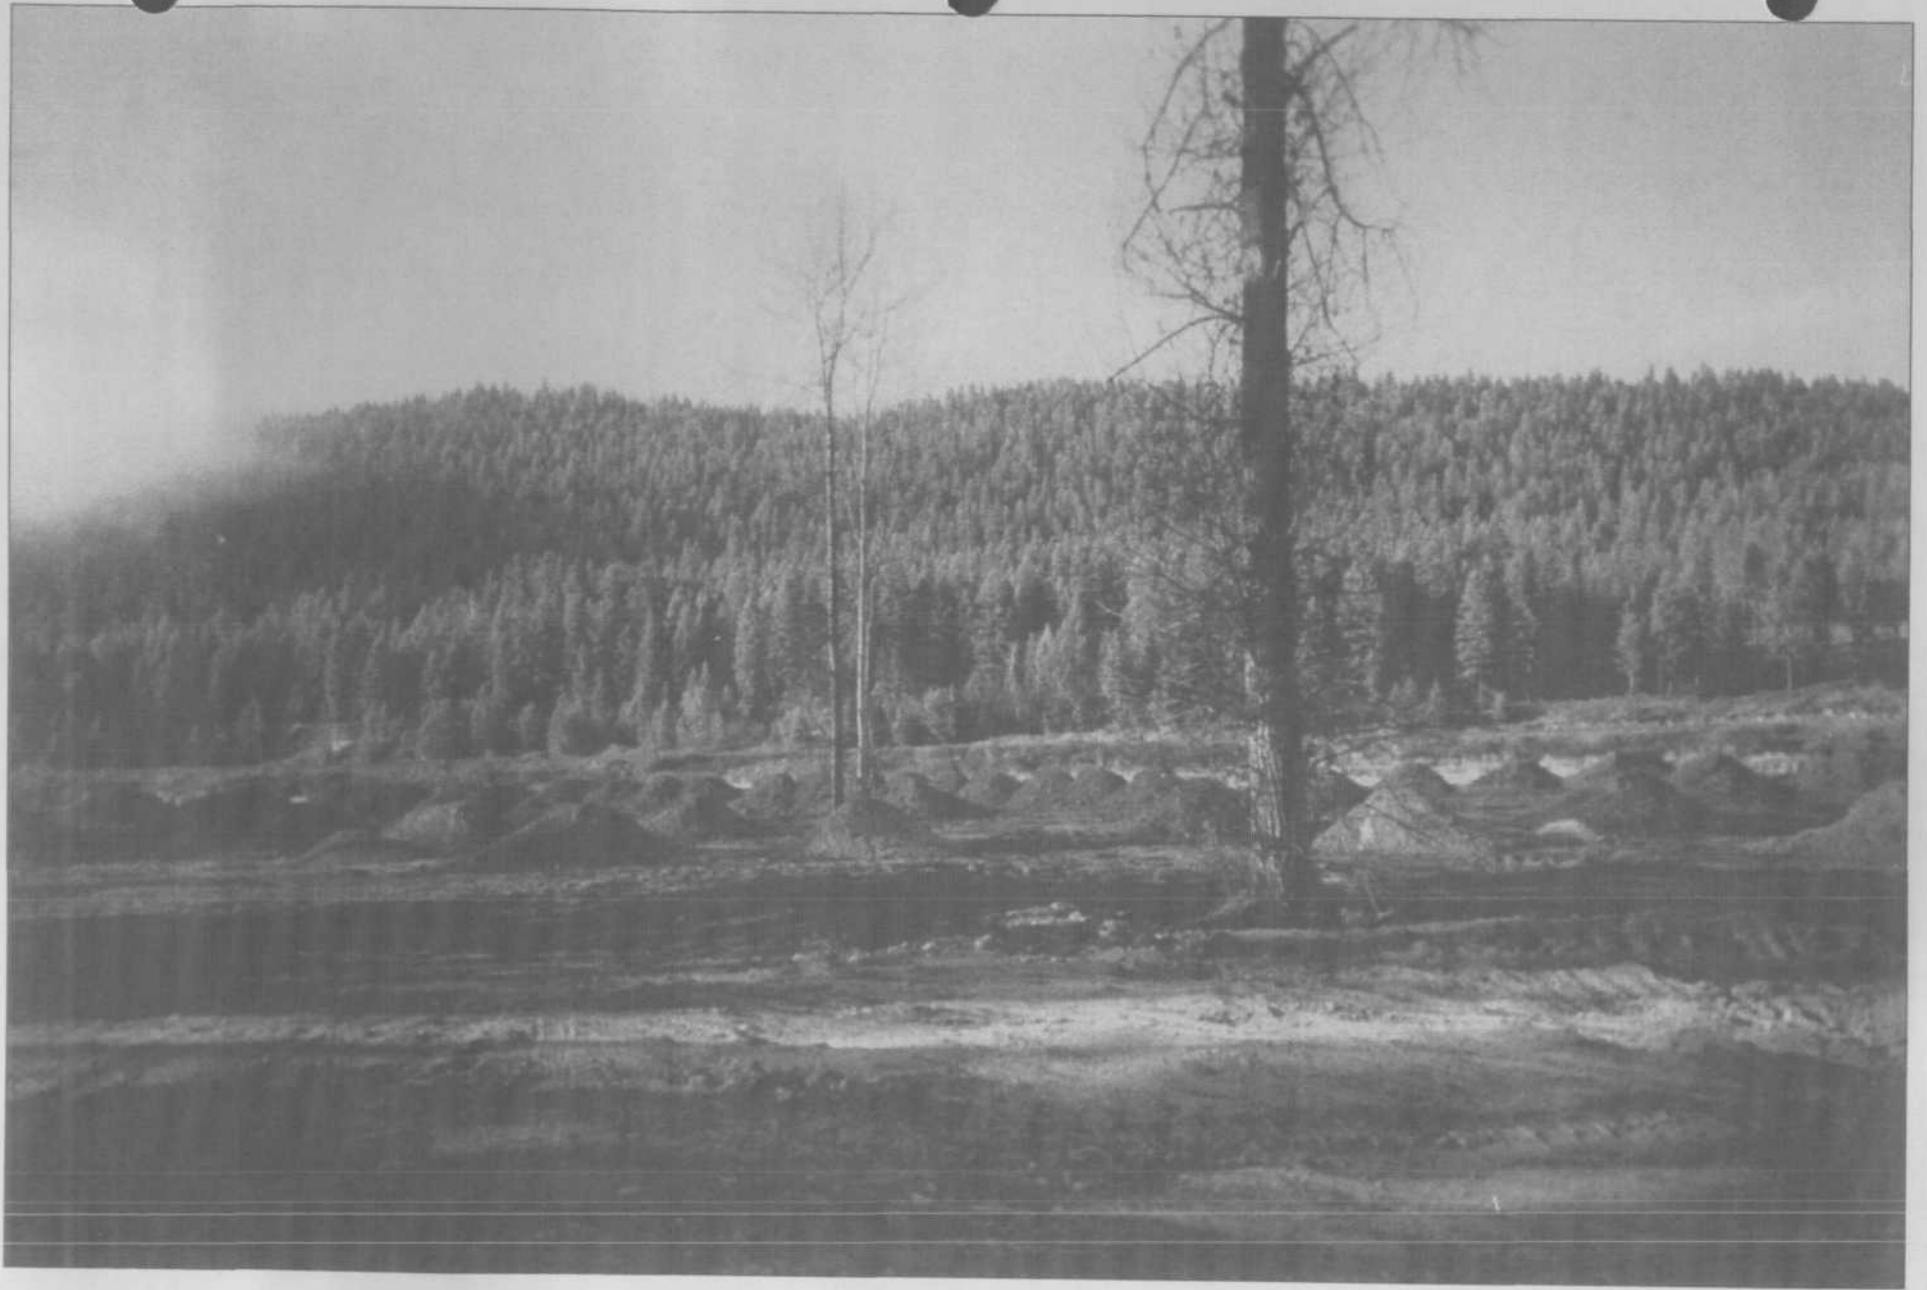
Flyway Site - Backfill Dumped and Ready for Spreading

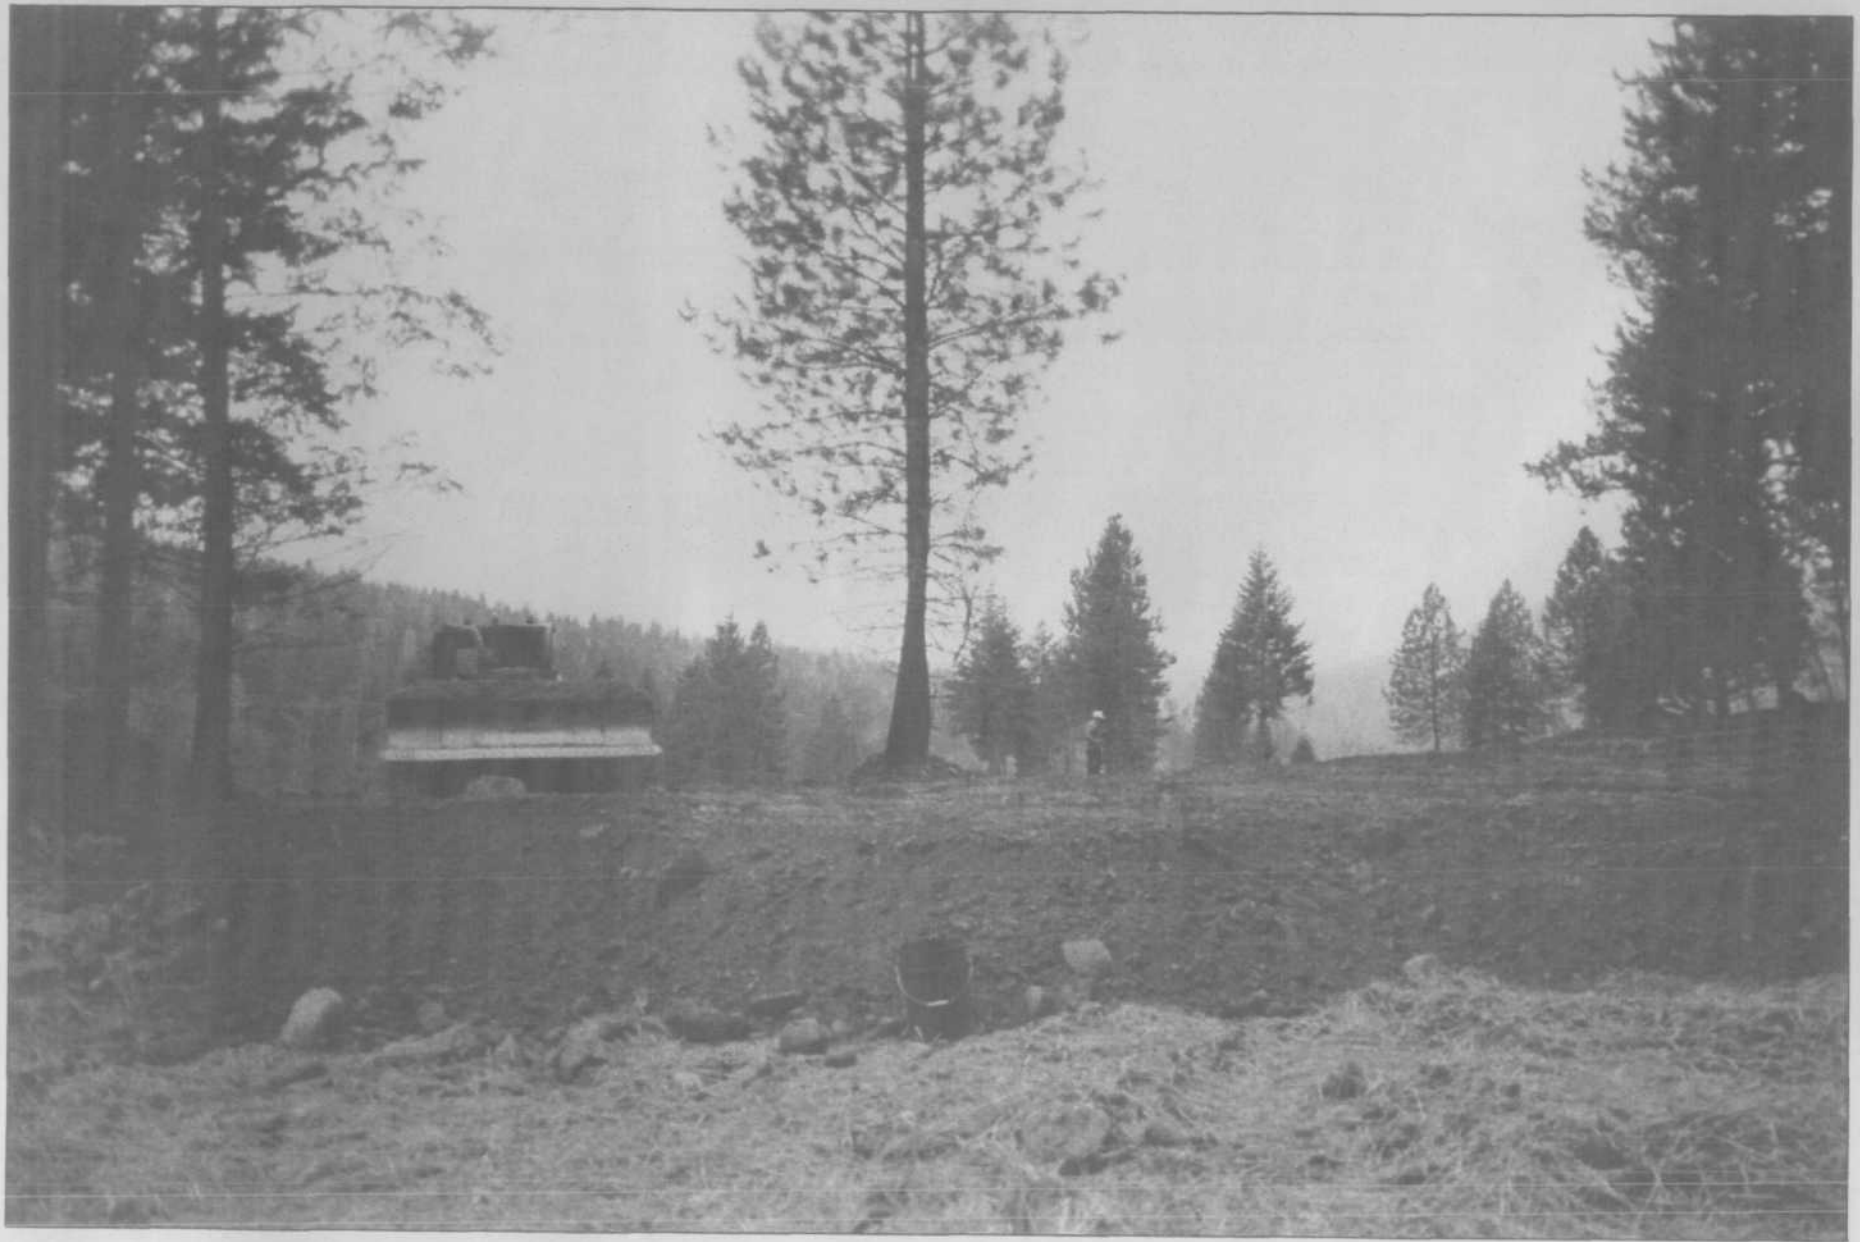
Flyway Site - Showing Depth of Backfill

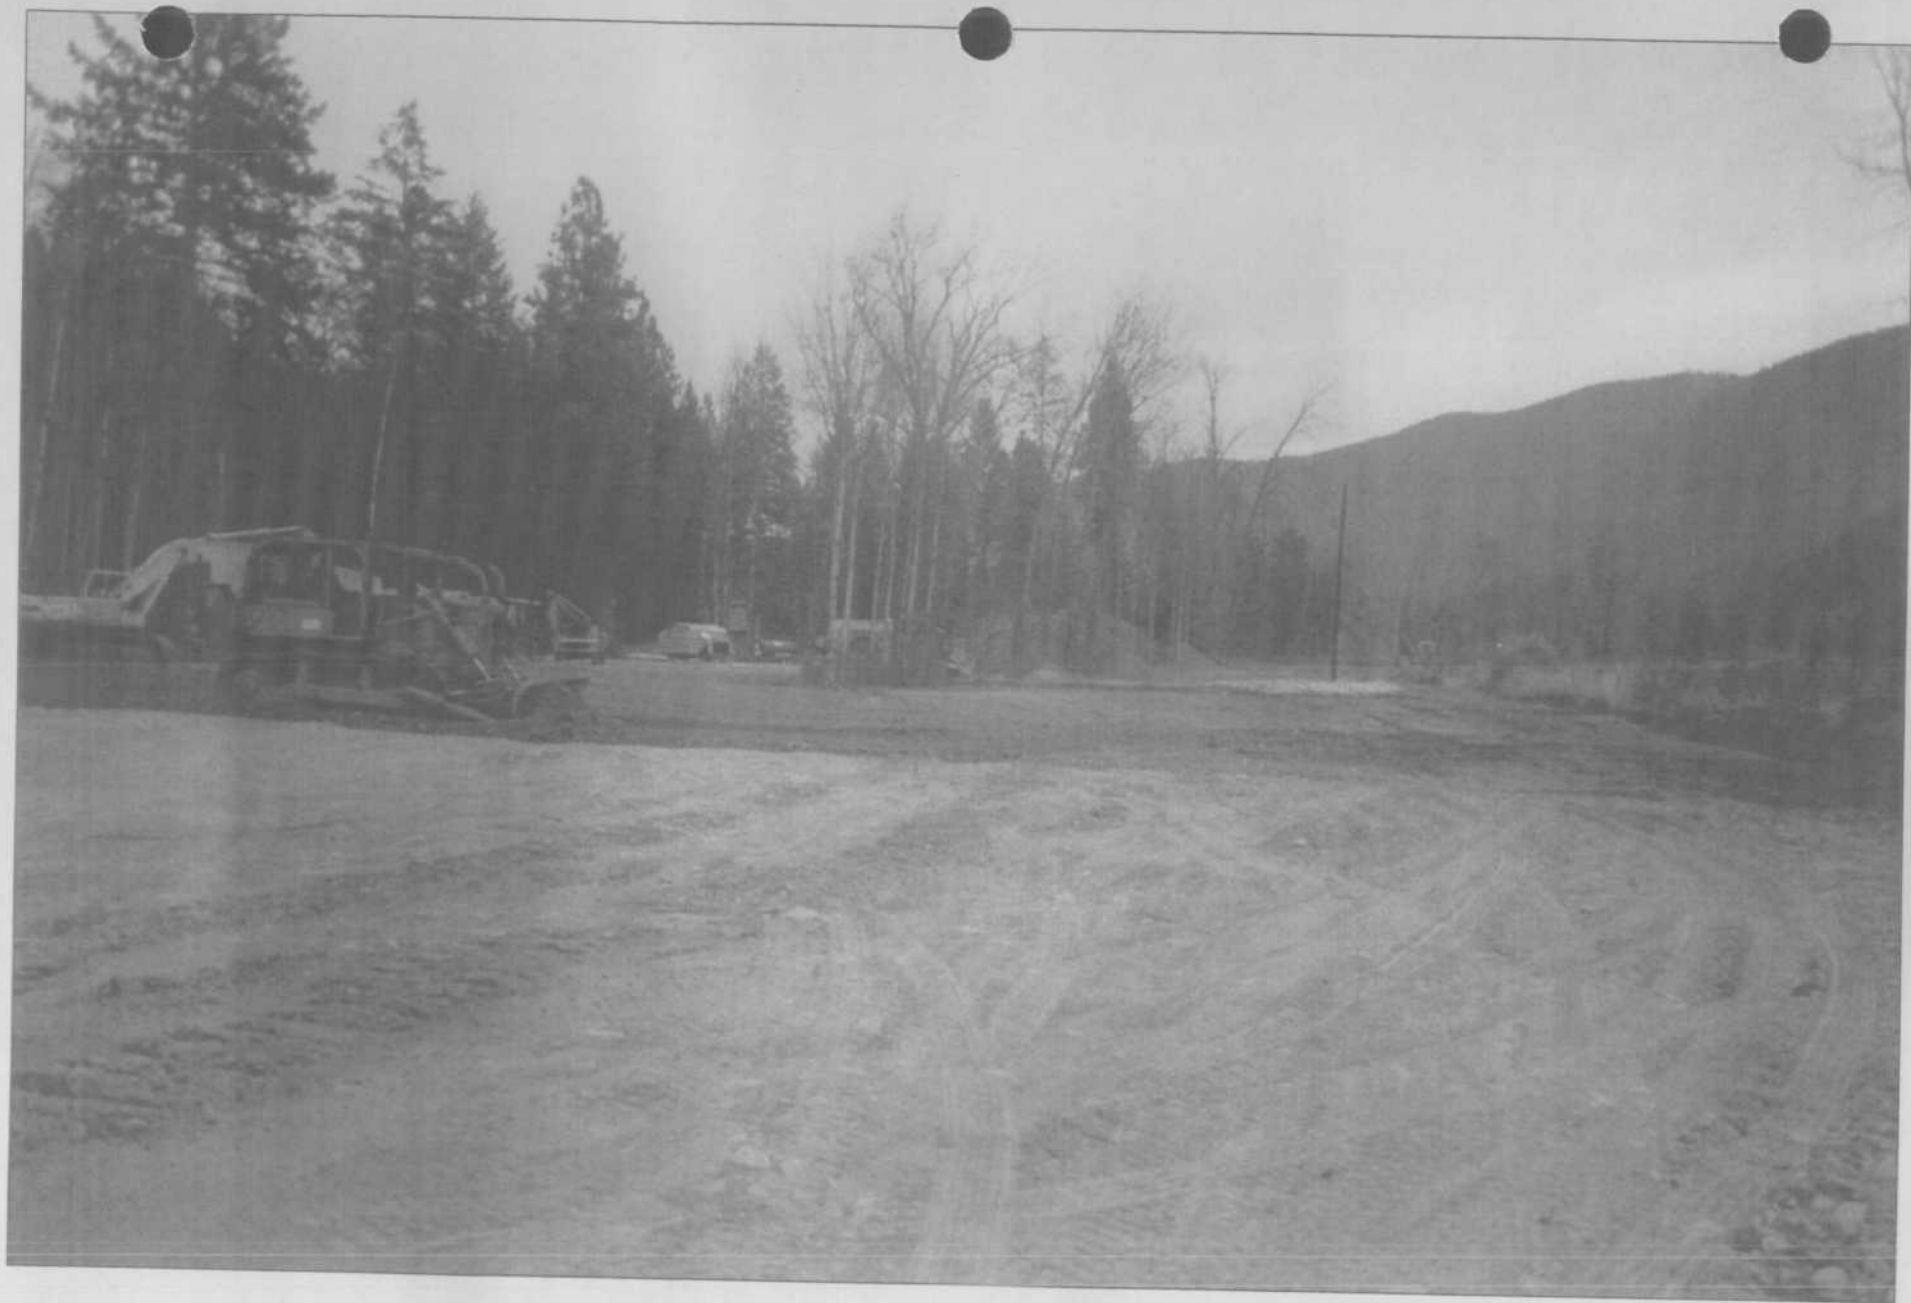
Flyway Site - Final Grading of Backfill

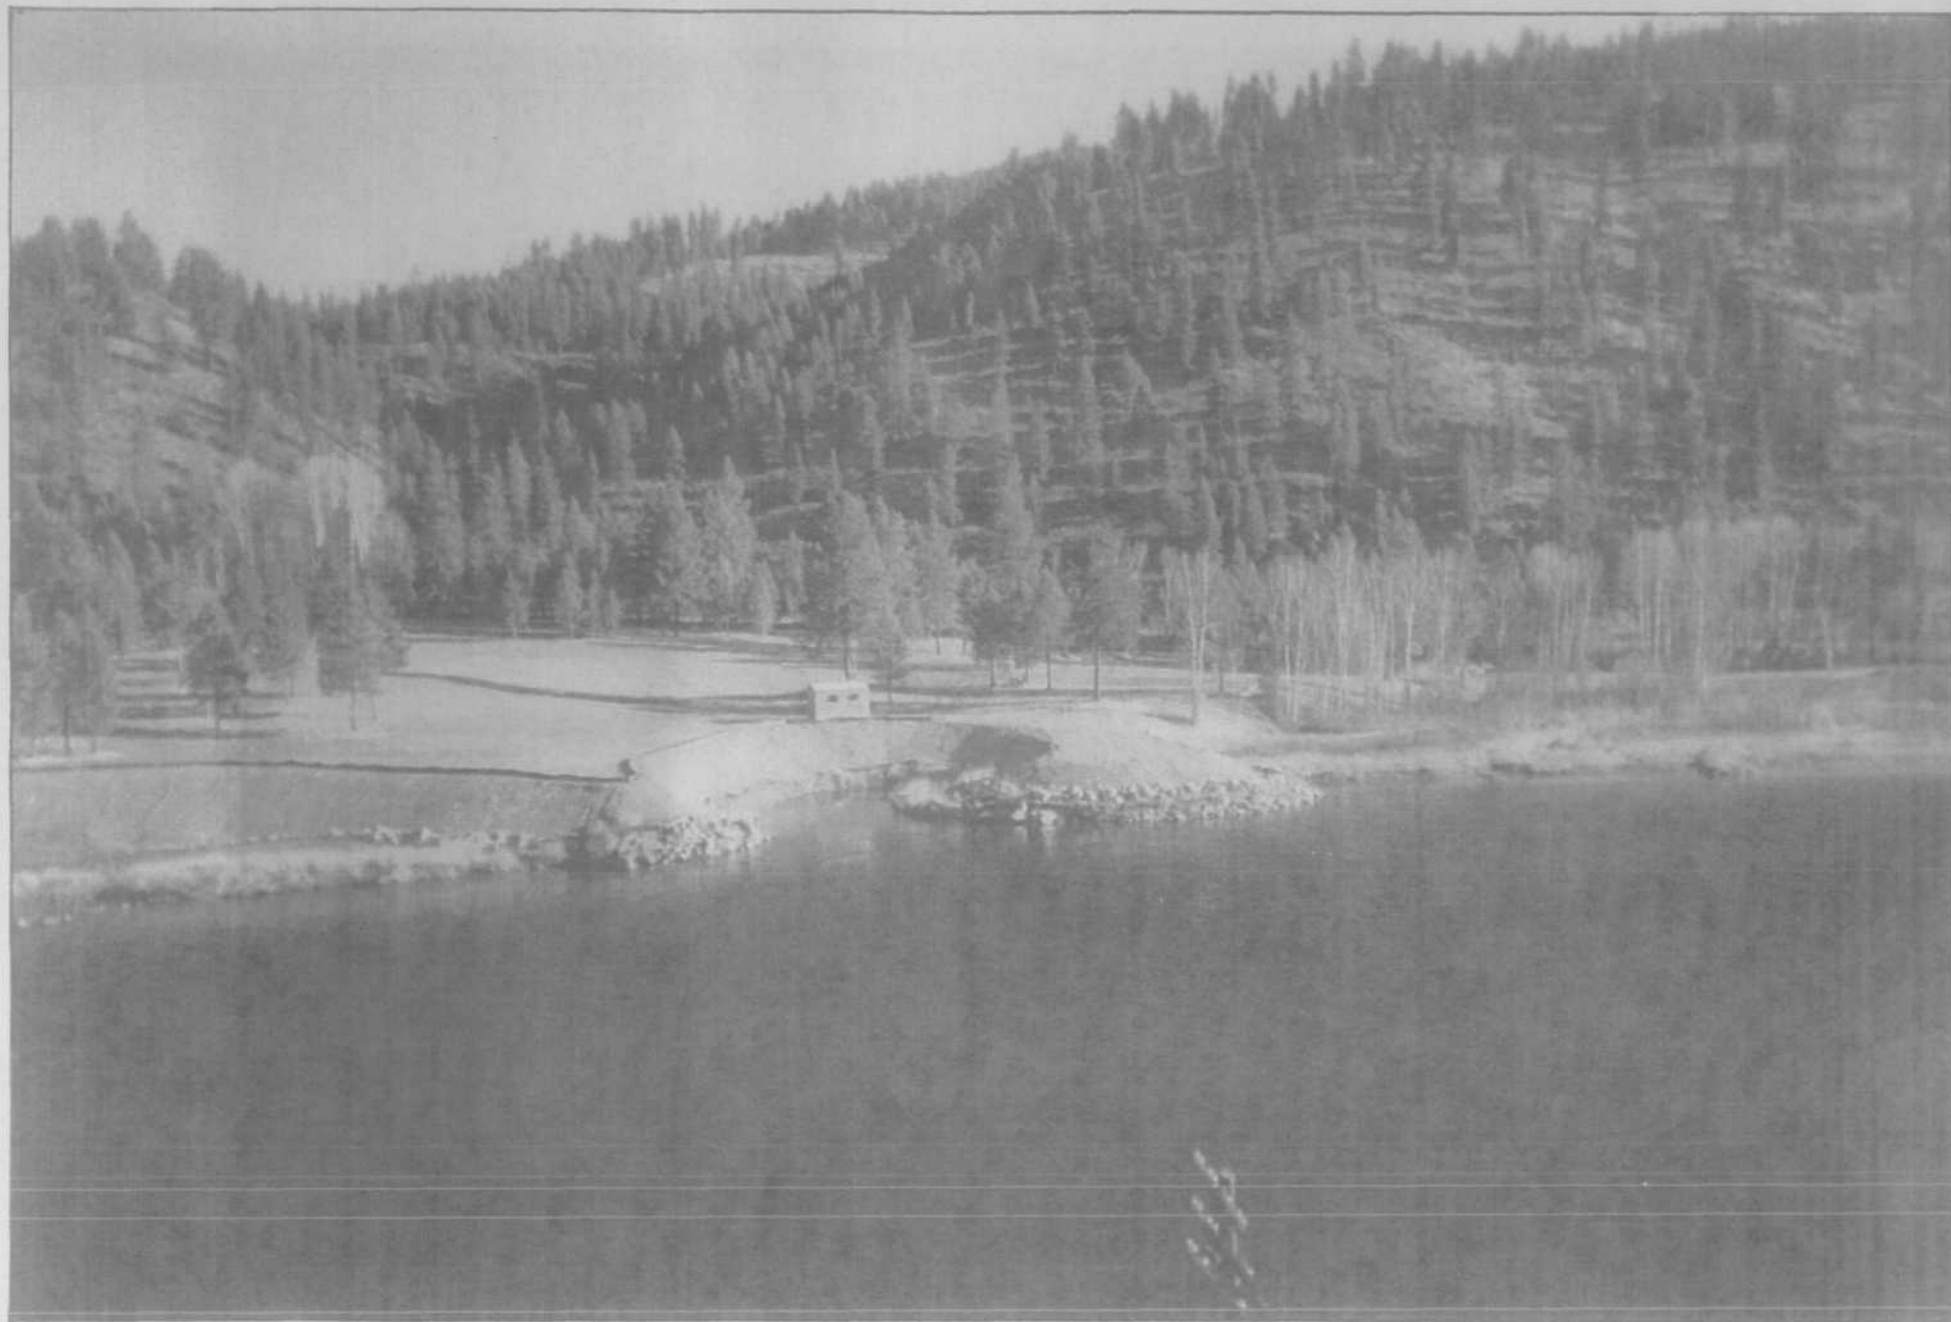
Flyway Site - Excavated, Backfilled and Graded - Ready for Hydroseeding

The site was hydro seeded November 22-24. A 6-foot high chain link permanent fence will be installed in the spring of 2005 or earlier if weather permits.

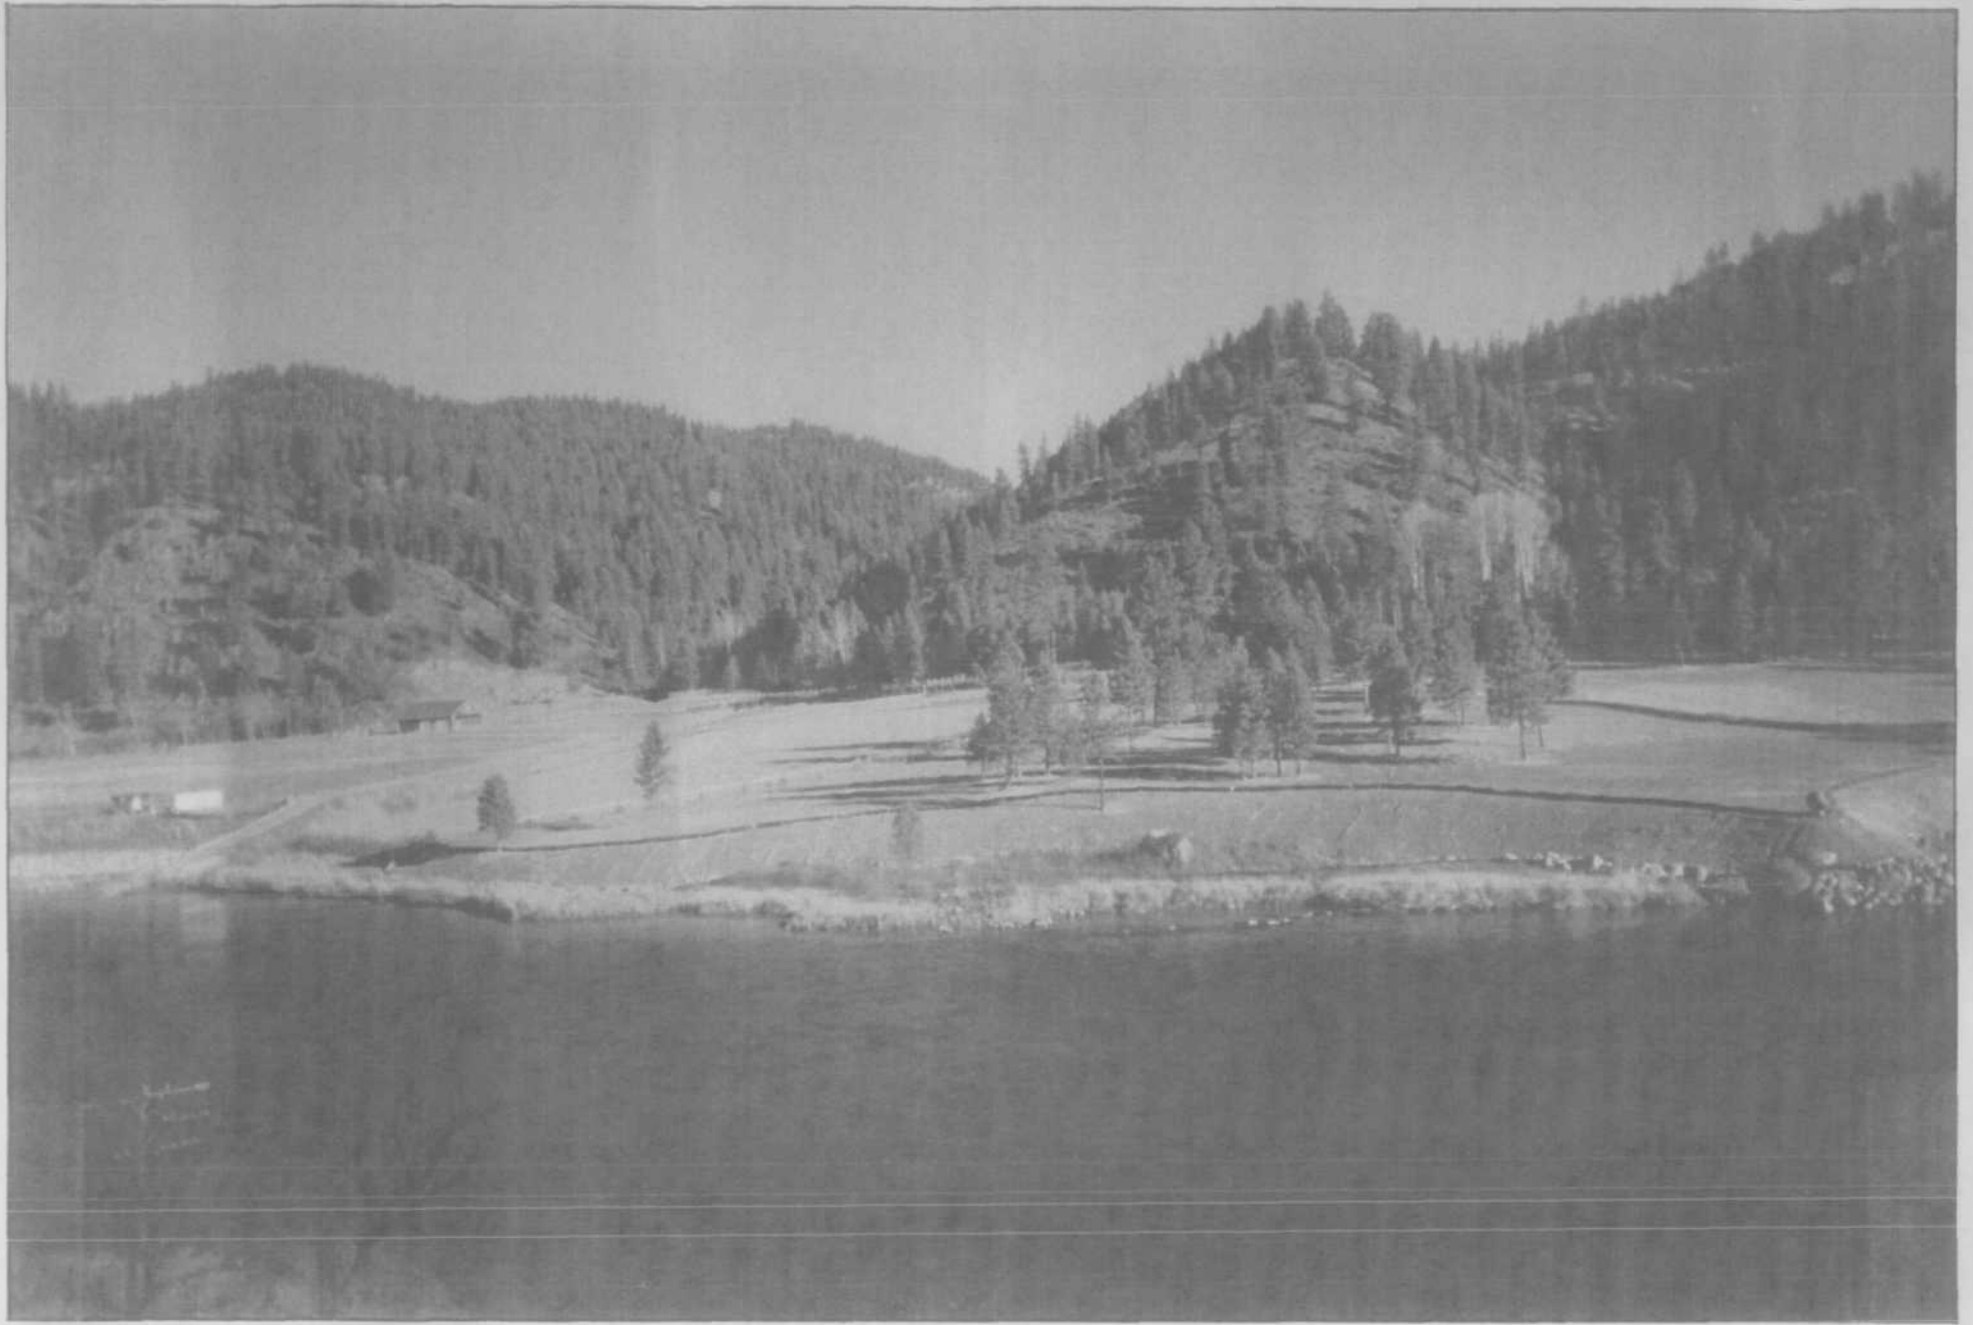
Flyway Site - Excavated, Backfilled and Graded - Ready for Hydroseeding
